Inspection Report

Property Address: 5555 Sample Avenue Seattle WA 98103

Meridian Inspections, LLC

Date: 6/7/2016	Time:	Report ID:
Property: 5555 Sample Avenue Seattle WA 98103	Customer: Mr. Sample Mrs. Sample	Real Estate Professional:

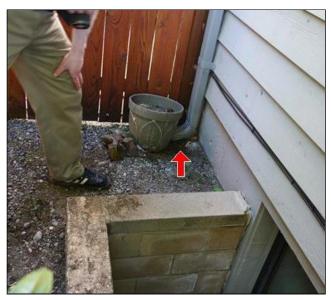
D. (3) Gutter downspouts at the north/east and south/west corners of the home are discharging too close to the foundation of the home. These downspouts appear to be clear from debris, however should be discharging at least 5 feet away from the home where possible. I recommend adding downspout extensions or splash blocks to these downspouts to promote drainage of water away from the foundation.

D. (4) Downspout at north/east corner of home discharging next to foundation.

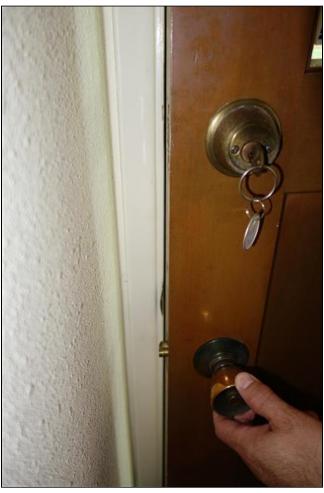
♣ ■ The exterior door between the kitchen and the back deck has several conditions which should be corrected by a qualified contractor. The door is not closing properly and contains a double keyed dead-bolt. Double-keyed dead-bolts are not permitted by modern building codes due to egress requirements, which require that all means of egress (ways to get out of the house), such as windows and doors, must be operable from the inside without the use of special knowledge or tools. This door also does not contain safety glass.

B. (1) Kitchen door to back deck does not properly close and contains a double-keyed dead-bolt.

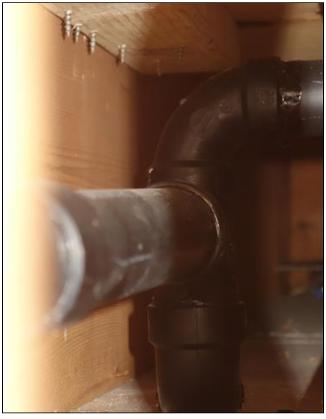
C. (3) At the time of inspection it was noted that the first floor bathroom shower was missing a drain trap. Upon further evaluation of photos taken during the inspection, this was determined not to be the case. The shower drain does have an appropriate trap and is therefore not noted as a defect on this report.

C. (3) P-trap for first floor bathroom.

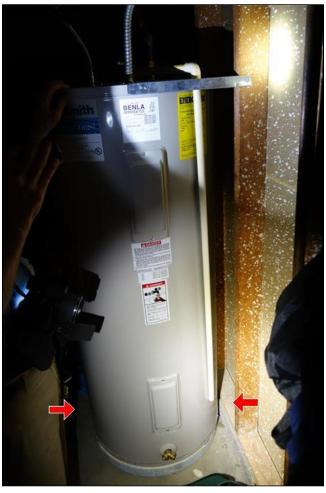
D. (2) The hot water heater is missing one of the required seismic straps. Water heaters should have two straps in each of the top 1/3 and bottom 1/3 of the unit to prevent tipping in an earthquake. Recommend having a qualified individual install a second strap in the bottom third of this unit.

D. (3) Water heater missing seismic strap on bottom 1/3 of unit.

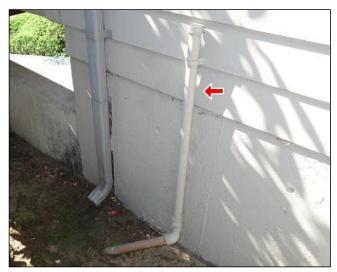
▲ E. An abandoned oil supply vent and supply pipe were both noted along the north/east side of the home. An underground oil storage tank is suspected in this area and should be properly decommissioned in accordance with local regulations.

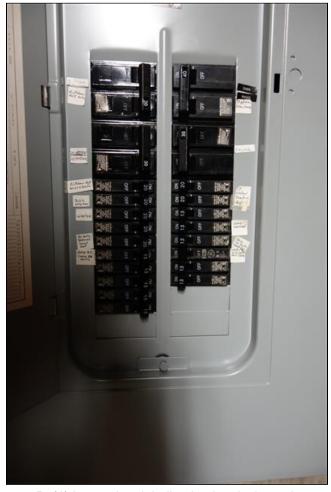
♣ B. The electrical panel for the home lacks complete labeling. Proper labeling is necessary for both maintenance/repair of the electrical system and safety. I recommend complete labeling of the circuits in this panel by a qualified individual.

B. (1) Incomplete labeling in electrical panel.

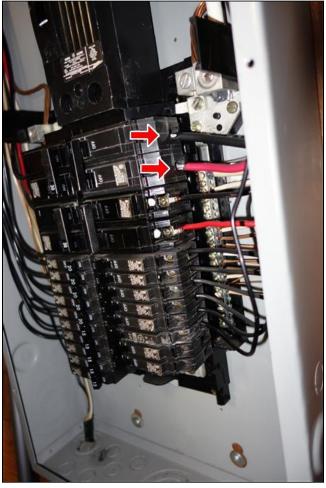
• C. (1) A single aluminum wire circuit (serving the oven/range) was noted in the electrical panel. Solid aluminum branch circuit wiring has a history of causing significant problems related to thermal expansion/contraction, however the circuit in question contains braided aluminum wires, which are less prone to these issues. The grounding wire for this circuit is a solid aluminum wire and should be evaluated by a licensed electrician in the context of other electrical work recommended in this report.

C. (1) Braided aluminum wiring in panel.

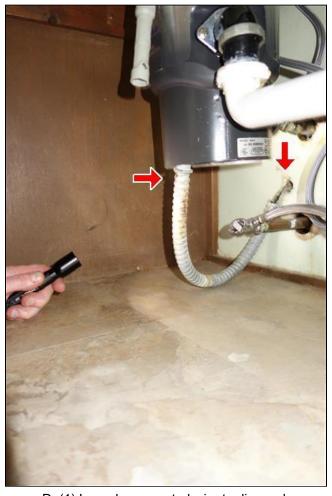
• D. (1) The wire connecting the kitchen disposal is loose, both at its connection to the disposal and the wall. The disposal bushing, which protects the wire from being damaged where it enters the disposal housing is present, but it is loose. The area where the wires exit the wall is missing proper protection. The area underneath the kitchen sink is commonly overcrowded with kitchen supplies, which can cause electrical wires to be disconnected. Recommend hiring a qualified electrician to repair as necessary.

D. (1) Loosely connected wire to disposal.

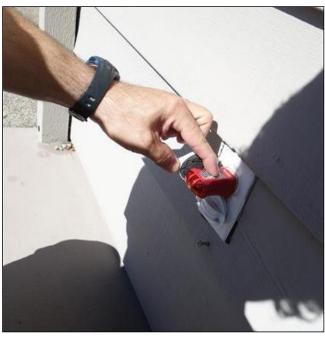
F. (2) Non-GFCI protected outlet on front deck.

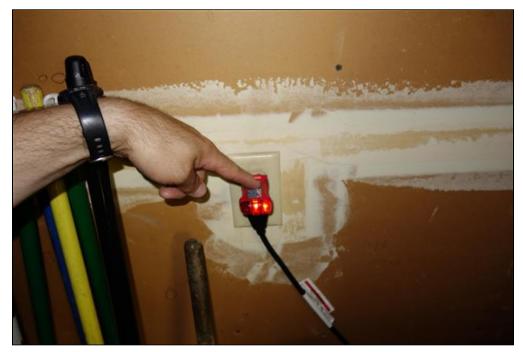
F. (2) Outlets in the laundry room and garage are not GFCI protected outlets. Modern building codes require all outlets in laundry rooms and garages to be GFCI protected. I recommend upgrading these outlets to GFCI outlets by a qualified electrician.

F. (4) Non-GFCI protected outlet in garage.

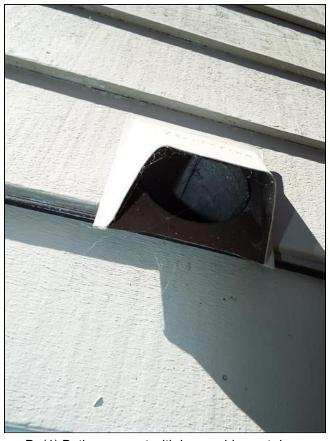
D. (1) One of the bath vents along the north/east side of the home has a flap which is not operating. These flaps prevent pests from entering the home. I recommend having the vent cover replaced by a qualified professional.

D. (1) Bathroom vent with inoperable vent door.
